A CULTURAL RESOURCES ASSESSMENT
OF SELECTED MAGNETIC ANOMALIES
FREEPORT HARBOR, TEXAS
45-FOOT PROJECT

A report submitted to the U.S. Army Corps of Engineers,
Galveston District, by the Texas A&M Cultural Resources
Laboratory in partial fulfillment of Purchase Order
Number DACW64-80-M-0869.

November, 1980

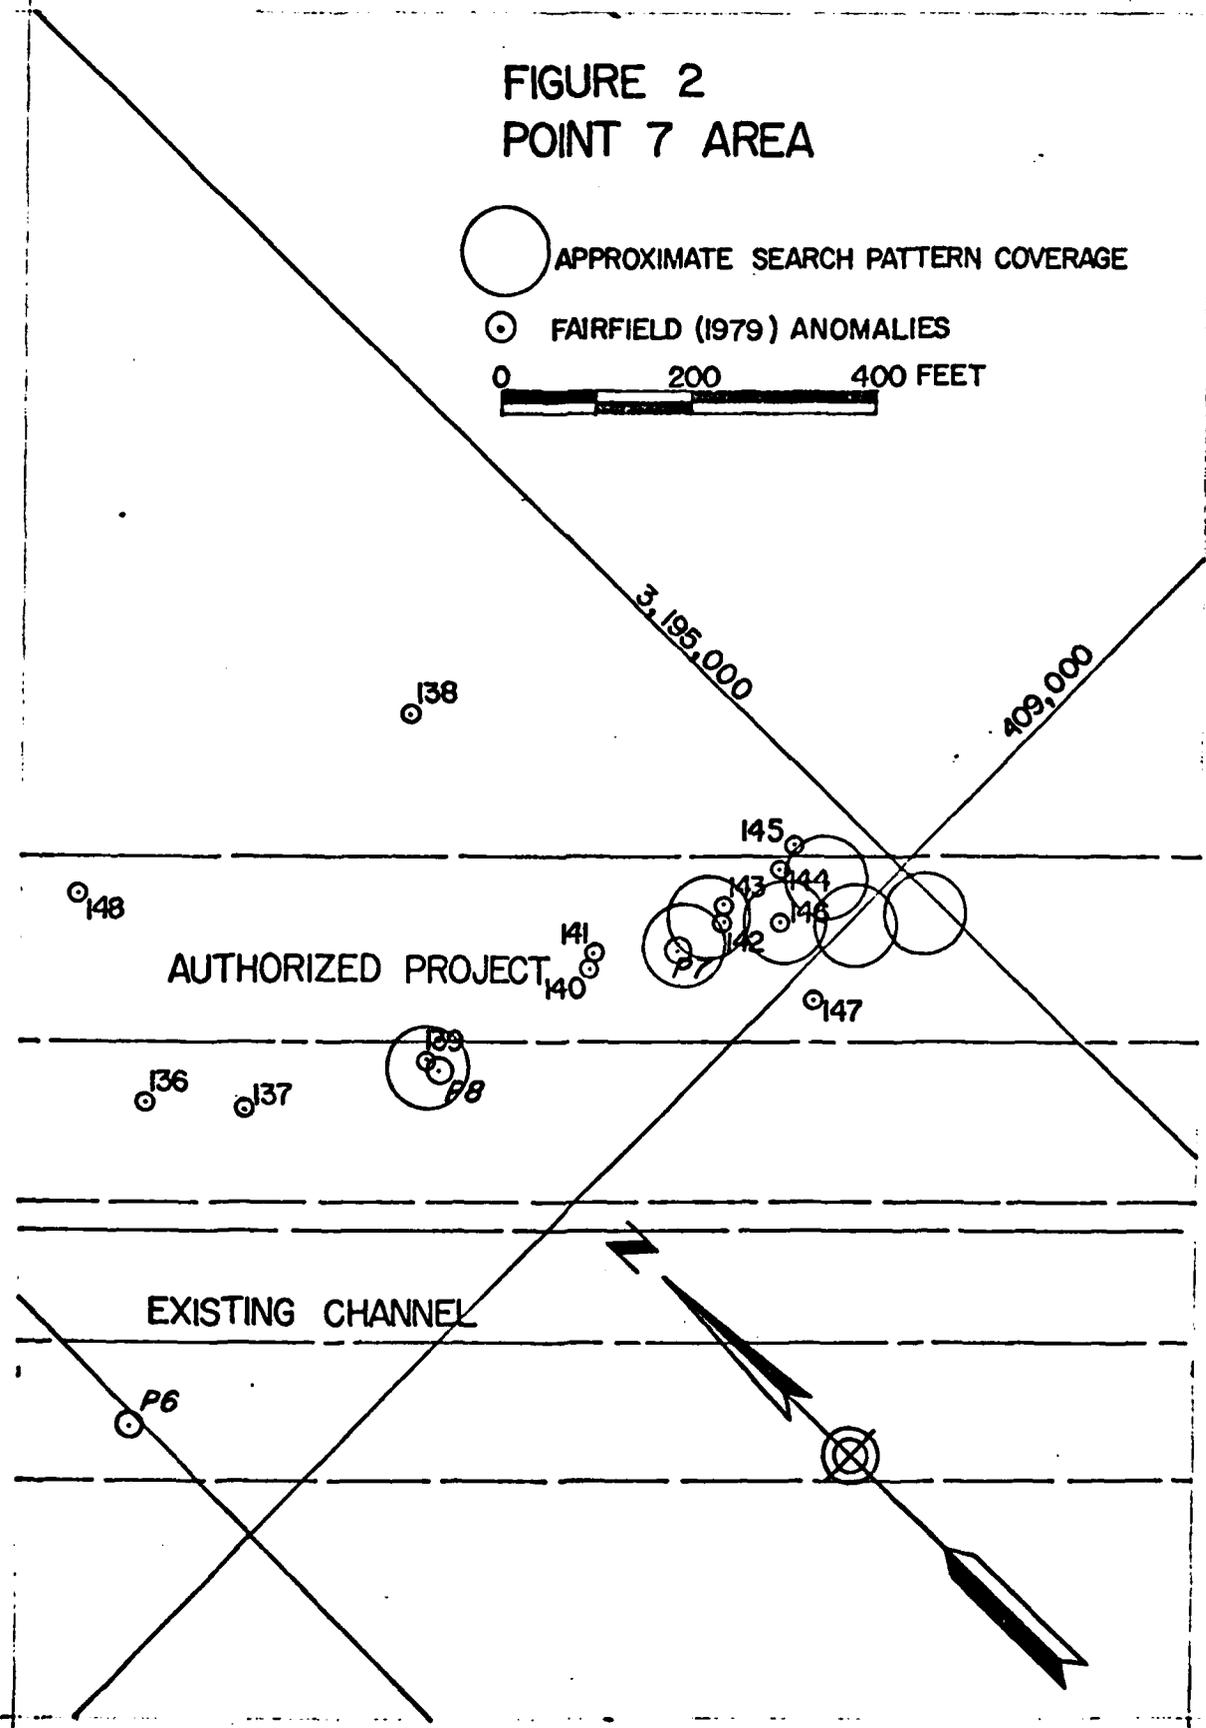
FIGURE 2 POINT 7 AREA

Point 7 (Figure 2): Dive 3. Positioned approximately 15 m east of Point 7 in approximately 13.5 m of water, the investigating divers found a smooth clay bottom. The clay was noted to be firm but very cohesive under a 10-15 cm thick layer of suspended and/or partially suspended clay particles.

Dive 4. Centered over Point 7, the divers found a smooth undisturbed clay bottom.

Dive 5. Bouyed over anomaly 145, the bottom predominantly consisted of smooth clay although some minimal bottom disturbance seems to have occurred in the eastern portion of the search area.

Dive 6. Located approximately 20 m east of anomaly 145, the search pattern again found a uniform clay bottom with a single groove of 0.5 m wide by 0.5 m deep gouged in the clay. A single waterlogged driftwood fragment of approximately 10 cm in diameter and 20 cm in length was recovered.

Dive 21. Positioned over or very near anomaly 139 in 12.6 m of water, the magnetometer indicated a 12 gamma point source. The divers found a relatively smooth clay bottom but failed to locate any materials which might have caused the 12 gamma magnetometer reading.

Dive 22. This search was centered over an 11 gamma anomaly approximately 25 m southeast of plotted anomaly 146. The divers found a dredge scar in the clay bottom, a modern fire brick fragment reading "...LLSUILLE...AVAGE," a one m length of very rusty welded link chain (approximately five cm link length), two very rusty sheet iron fragments and one small fragment of friable (charred?) wood.

Dive 23. Located 46 m due east of anomaly 146, this dive was to examine a magnetometer-indicated 10-11 gamma anomaly source. No anomaly source was located by the search.

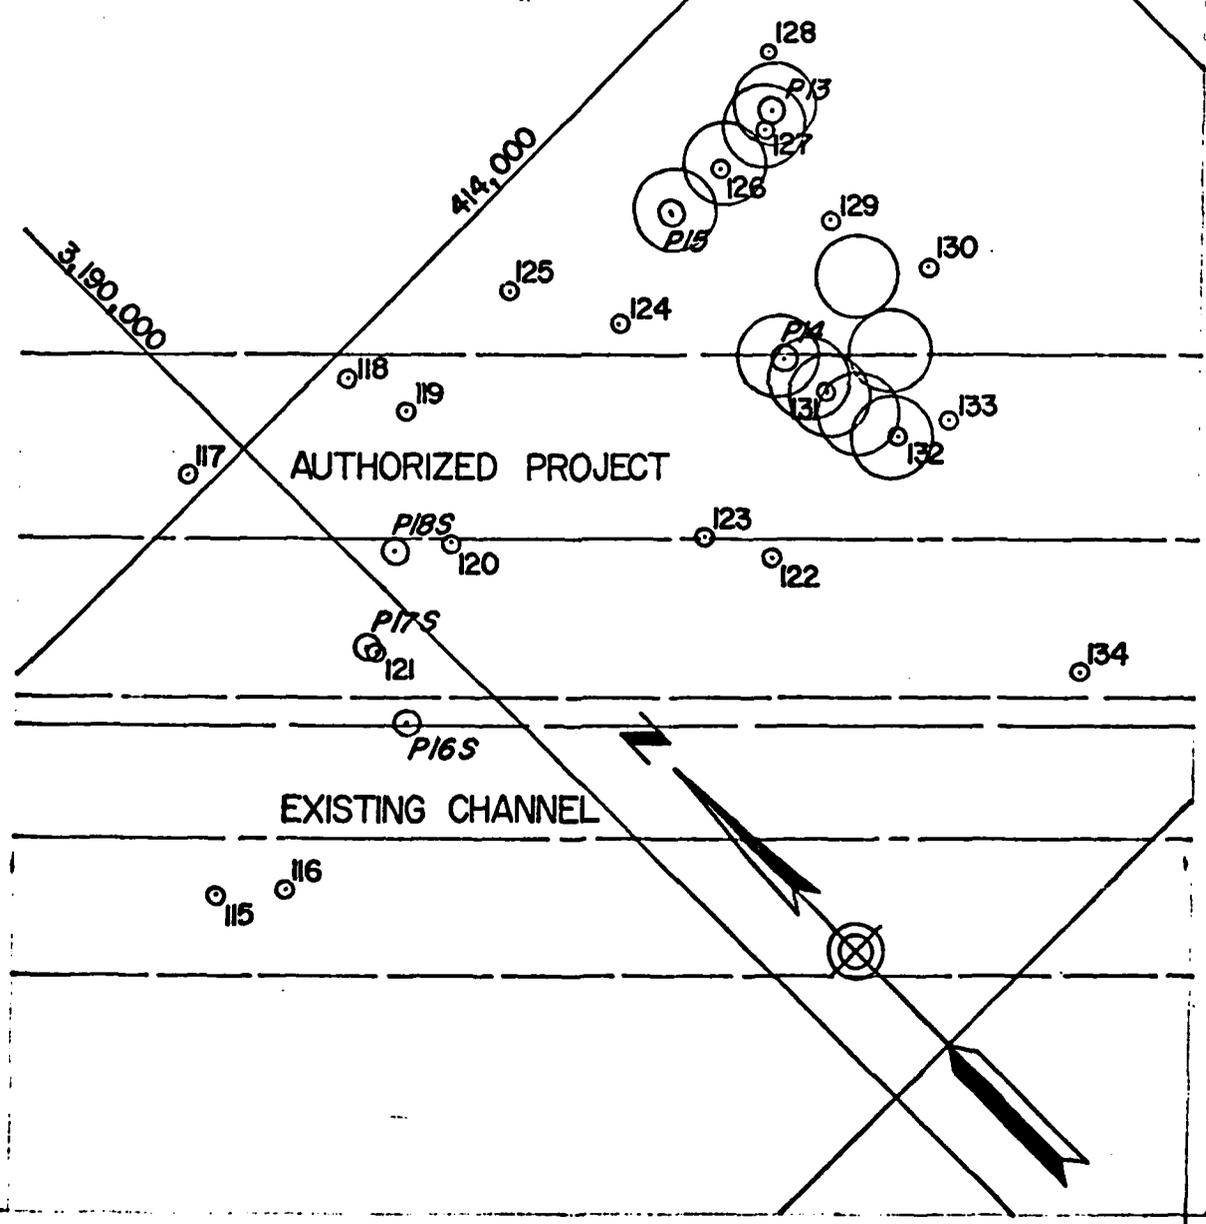
FIGURE 3
POINT 13, 14 AND 15

Point 13 (Figure 3): Dive 7. Centered over Point 13, the dive was made in 12 m of water and found a relatively smooth clay bottom and a single small waterlogged driftwood fragment.

Dive 8. This search was centered off an anchor set approximately 12 m west of Point 13 near anomaly 127. The divers found a smooth clay bottom and a single somewhat corroded 12 oz beverage container bearing the barely legible label "Miller Lite."

Point 14 (Figure 3): Dive 11. Centered on the buoy set on Point 14, the dive encountered a clay bottom gouged with at least two dredge scars of approximately 1.5 m in width and up to 0.5 m deep.

Dive 12. Dive 12 was made off of a boat anchor set over anomaly 131. The divers found that the clay bottom had been marred by a number of dredge scars. A short length (1-1.5 m) of nylon rope (approximately 3 cm in diameter) was found.

Dive 13. Centered between anomalies 131 and 132, the search found a dredge-damaged bottom consisting predominantly of clay and a light scattering of apparently disturbed oyster shells. A modern waterlogged board of approximately 2 cm X 15 cm X 1 m was recovered in the search.

Dive 14. Dive 14 was made from an anchor located on anomaly 132. The divers reported finding numerous dredge scars in the clay bottom, a few scattered oyster shells and a small thin lens of sand mixed with shell. No artificial materials were located.

Dive 15. Placed roughly 37 m east of Point 14, the divers found only a few shallow dredge trenches in the clay and a thin scattering of oyster shell fragments.

Dive 16. Centered approximately at the midpoint between Point 14 and anomaly 131, this dive rechecked the area examined by dives 11 and 12, again with negative results.

Dive 17. Dive 17 was conducted from an anchor approximately 37 m south-east of Point 14 and overlapped two of the previously checked search patterns. Additional disturbances were noted on the clay bottom; however, no cultural debris was found.

Point 15. (Figure 3): Dives 1 and 2. Essentially these two dives were tests conducted to determine visibility and bottom conditions. After brief exploratory free-swimming bottom searches, the divers determined that a tethered technique would be required to provide an adequate search pattern. Artificial illumination was found to be of no assistance in the light-diffusing, turbid waters near the bottom.

Dive 9. This circle search was conducted off a boat anchor which was set over anomaly 126. A smooth clay bottom was encountered.

Dive 10. This dive was centered off a buoy anchor set at Point 15. The divers found a smooth clay bottom which was cut with a single long, narrow (0.5 m wide and 10.5 m deep) groove. A very corroded aluminum beverage can was recovered.

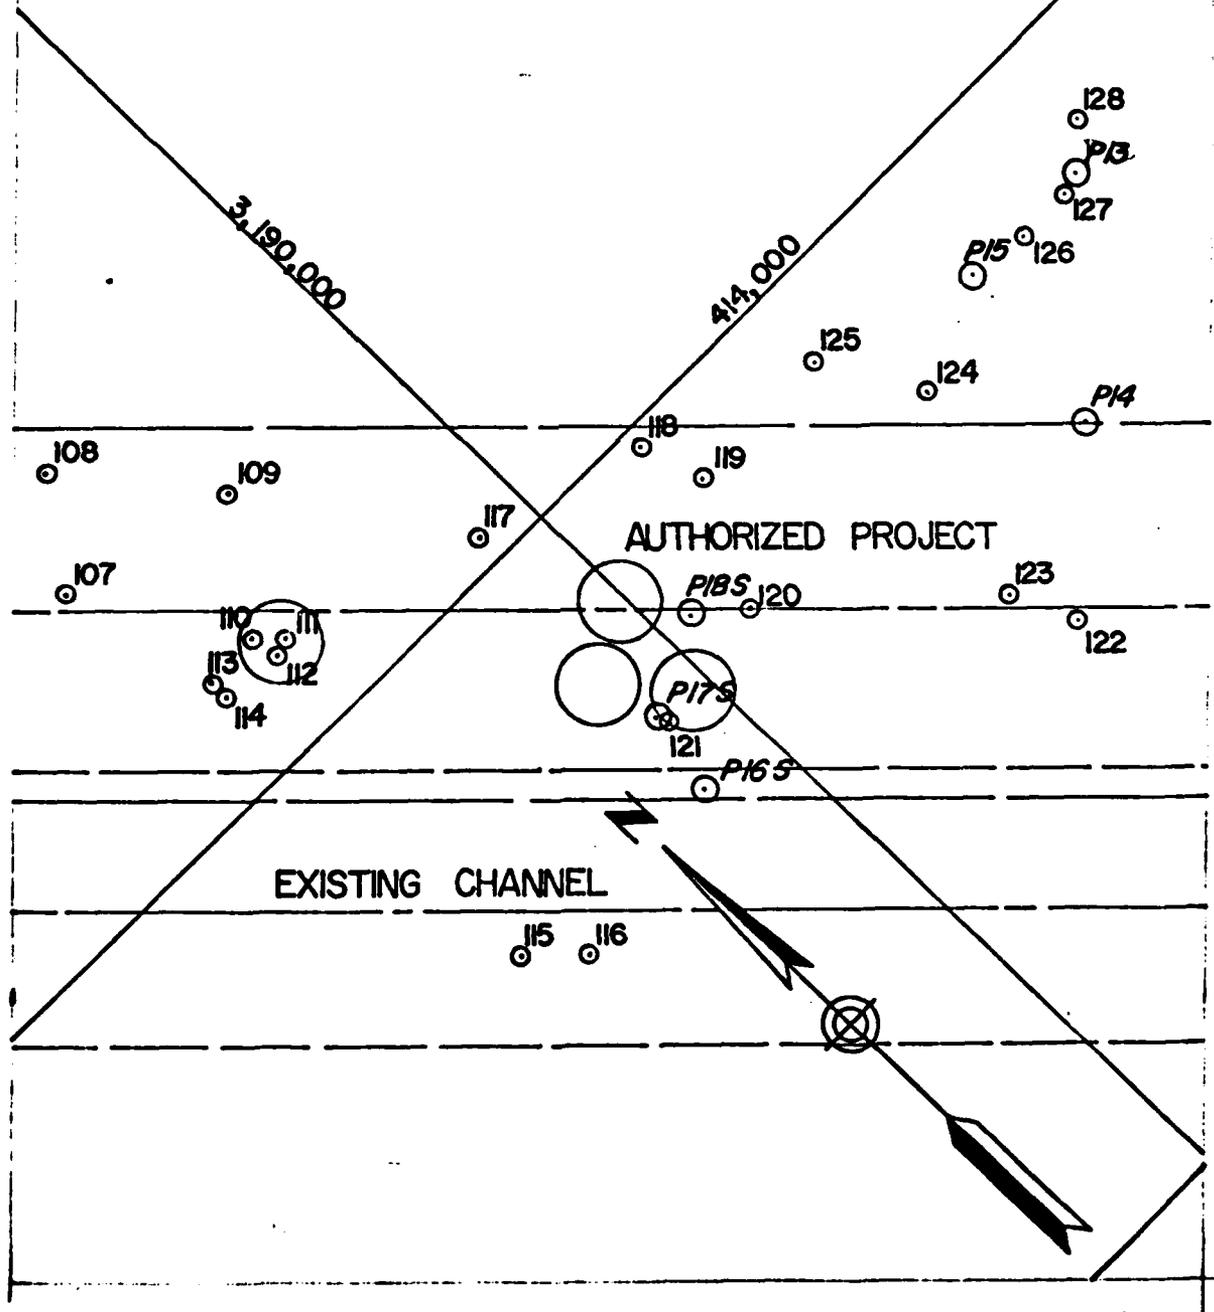
FIGURE 4
POINT 17 (AND 17 S) AREA

Point 17 (Figure 4): Dive 18. The only dive conducted in the immediate Point 17 area was centered on anomaly 111. The clay bottom was found to be extensively damaged by dredging. Trenches of over one meter in width and up to 1.5 m in depth made the bottom search difficult and hazardous. Except for a few shell fragments, nothing except bottom clay was found in the search.

Dive 24. Approximately 25 m north-northwest of Point 17 S over a 10 gamma magnetometer "hit", the divers found an extensively gouged bottom and a short length of wire rope. The recovered two fragments of wire rope were approximately one m in length, three centimeters in diameter and were badly corroded and encrusted.

Dive 26. Located approximately 37 m northeast of Point 17 S the divers found a dredge disturbance but failed to locate the cause of a 15 gamma magnetometer reading.

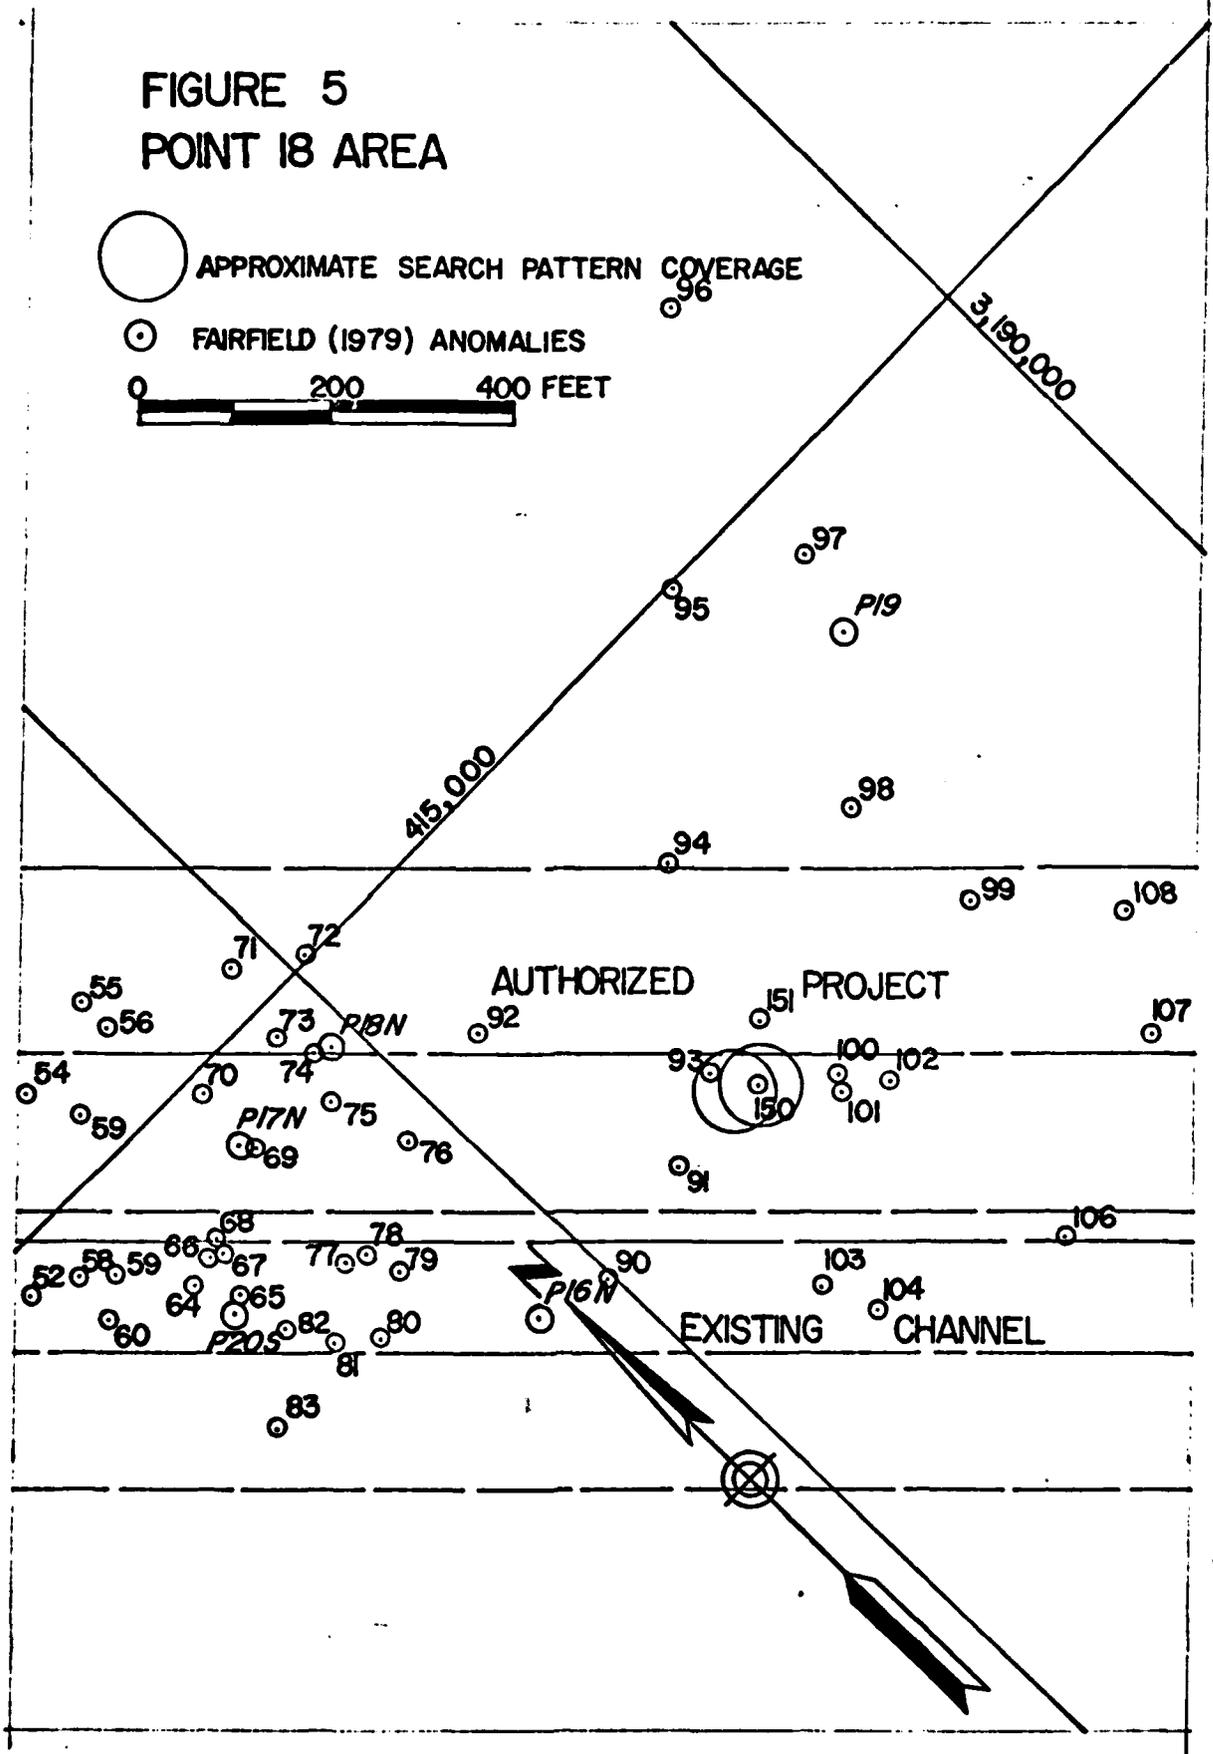
FIGURE 5 POINT 18 AREA

Point 18 (Figure 5): Dive 19. The dive boat was anchored over anomaly 150 from which the search was centered. The dive team reported that the bottom clays were scarred by more trenches presumed to be dredge scars.

Dive 20. The dive was centered off Corps of Engineers point 18A about nine m northwest of anomaly 150 and overlapping the search area of dive 19.

The dredge disturbed condition of the bottom was reaffirmed. The dive team found a sunken treated piling of approximately 1.5 m in length lying horizontally on the bottom. The divers reported the object had metal fasteners and possessed only a small amount of marine growth.
